Inspection Report

Property Address:
1234 Sample Street
Mishawka IN 46545

Certified Home Inspections LLC.

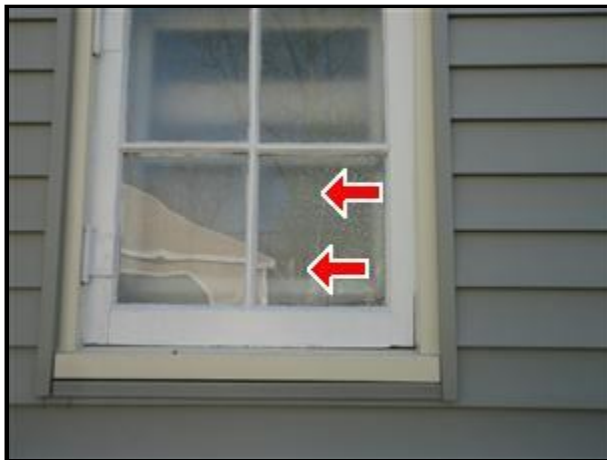
2.4 Picture 1

2.4 Cracked glass pane observed at rear of home. Use caution and repair or replace.

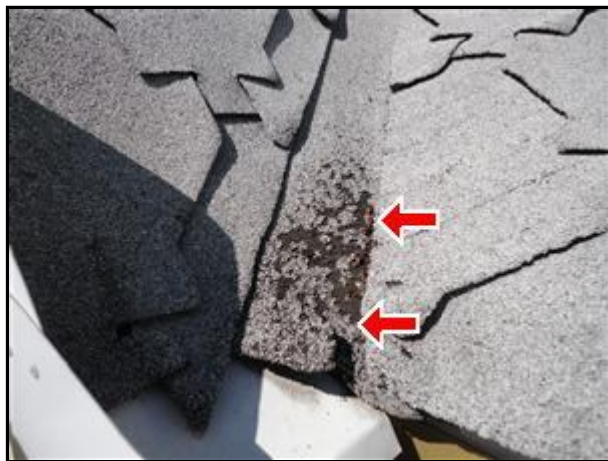
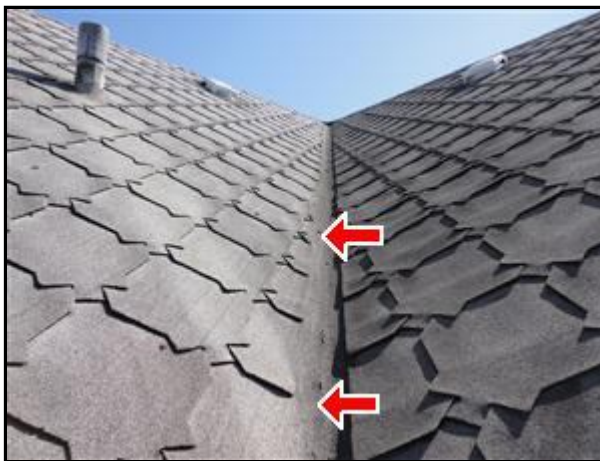
3.5 Picture 1

Most all valleys are deteriorating near eaves.

3.5 Most all valleys are deteriorating near eaves.

3.0 The roofing material is considered to be nearing the end of its service life. Recommend contacting a roofing contractor for estimate for replacement.

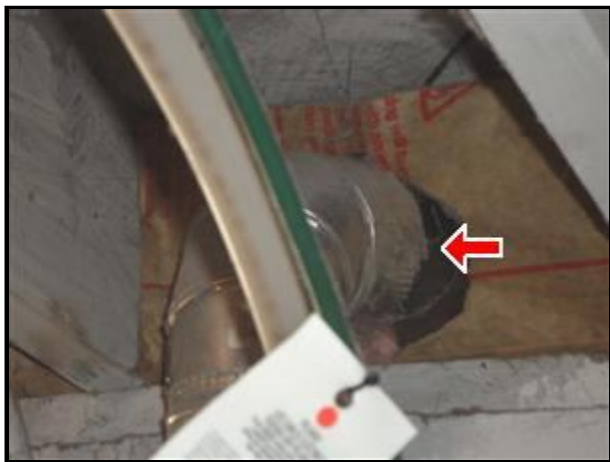
6.4 Picture 1

6.4 We are unable to evaluate the conditions inside dryer vents during inspections. Therefore we recommend cleaning or repairing existing dryer vents upon activation.

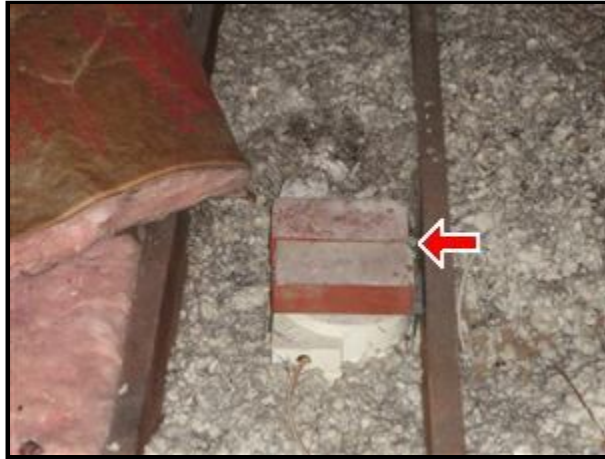
6.5 Picture 1

Bathroom exhaust fan is not vented properly in attic area. Recommend extending to within inches of roof

6.5 Bathroom exhaust fan is not vented properly in attic area. Recommend extending to within inches of roof vent or to the exterior for proper ventilation.

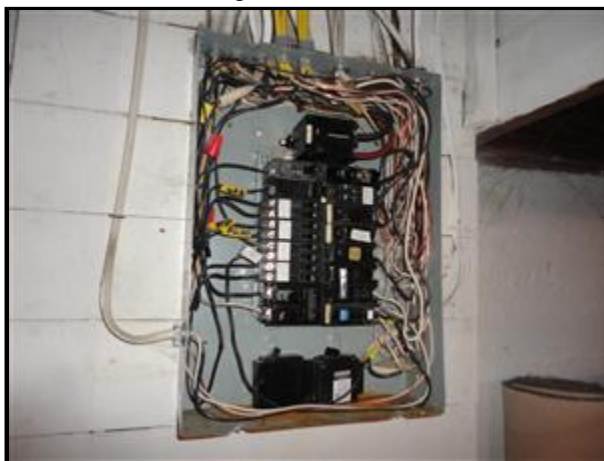
7.2 Picture 1

7.2 Main electrical panel was evaluated and is in good condition at this time.

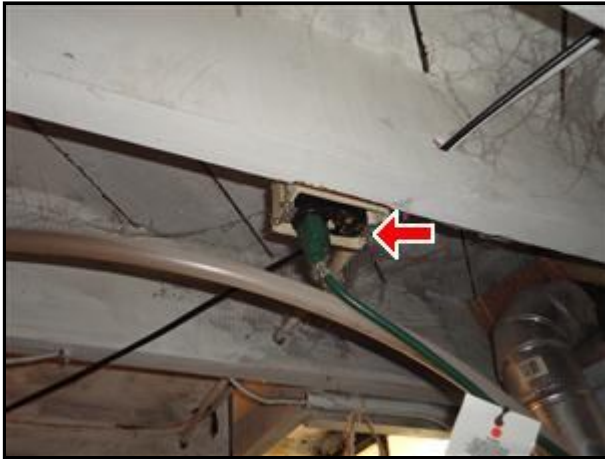
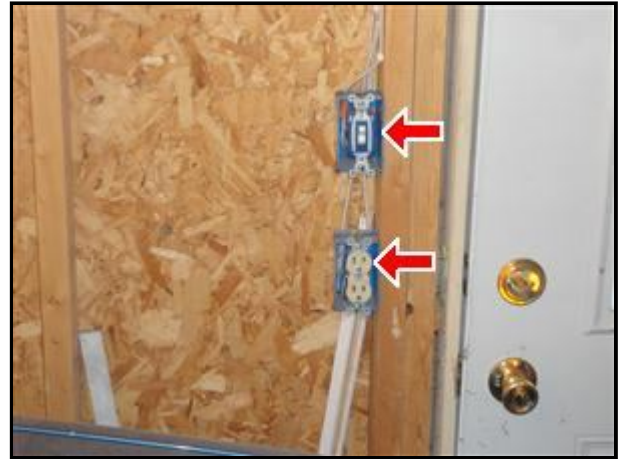
7.9 Picture 1

Broken receptacle observed in basement above washer/dryer. Replace for safety. Recommend replacing several missing outlet and switch cover plates in garage for safety.

7.9 Broken receptacle observed in basement above washer/dryer. Replace for safety. Recommend replacing several missing outlet and switch cover plates in garage for safety.

7.12 Recommend electrical items listed above for repairs be done by a qualified and/or licensed electrician.

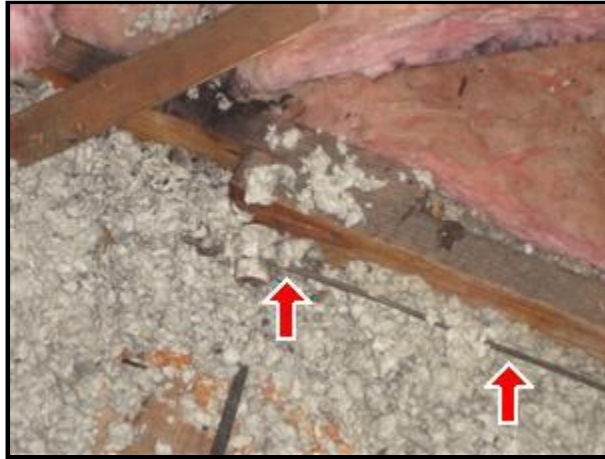
7.11 Picture 1

7.11 (1) Attic is insulated and Knob and Tube wiring is present. As a safety rule Knob and Tube wiring should never have insulation covering this wire. Unable to fully inspect older wiring at this time.

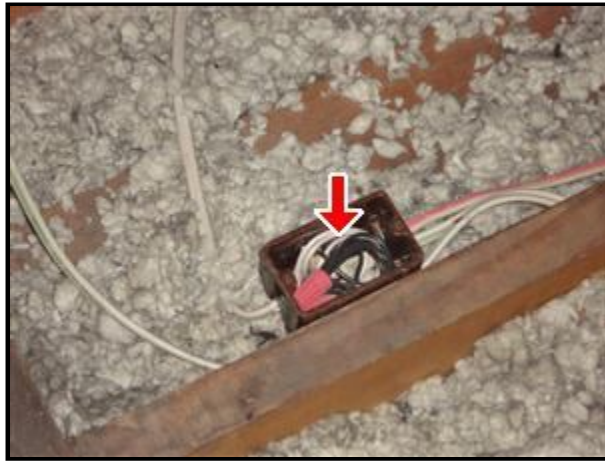
7.11 Picture 2

(2) Recommend replacing missing junction box cover in attic space for safety.

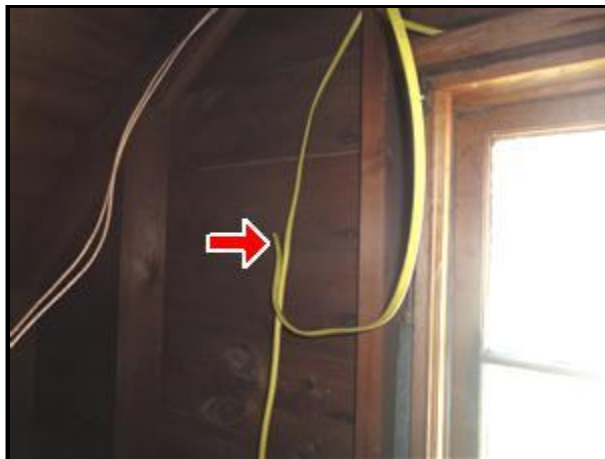
7.11 Picture 3

(3) Recommend junction box with cover for live wire end in attic space for safety.

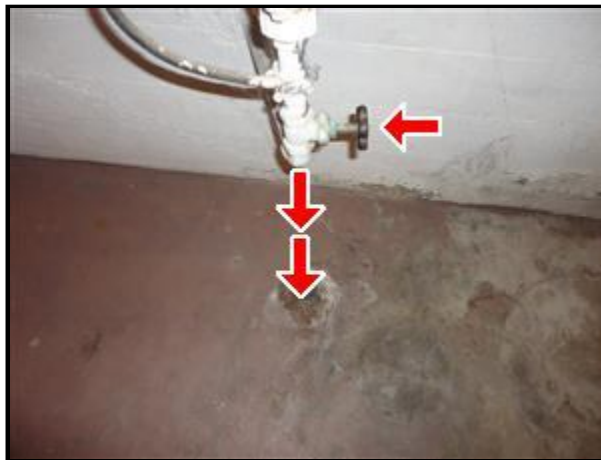
8.2 Picture 1

Main water shut-off valve is leaking and difficult to turn off at this time. Recommend repair or replace.

8.2 Main water shut-off valve is leaking and difficult to turn off at this time. Recommend repair or replace.

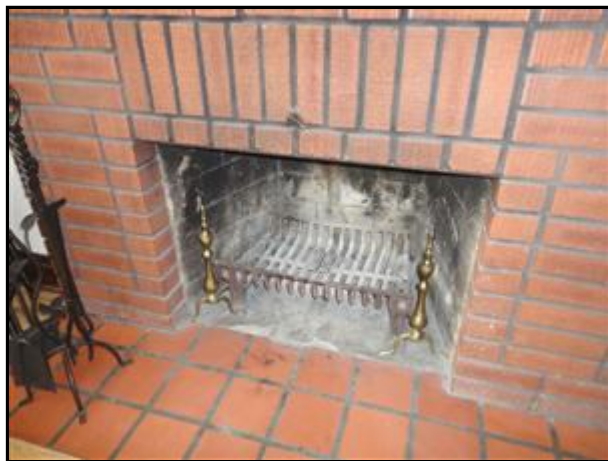
12.8 Picture 1

12.8 Fair amount of soot observed inside fireplace chimney lining. Recommend professional cleaning at this time for safety before firing.
